## CERTIFICATE OF ANALYSIS

## ASBESTOS INVESTIGATION WORK

## ABC TELEVISION STUDIO No. 21

REPORT ON INVESTIGATION OF ASBESTOS INSULATION  
ABC TELEVISION STUDIOS No. 21 & 22

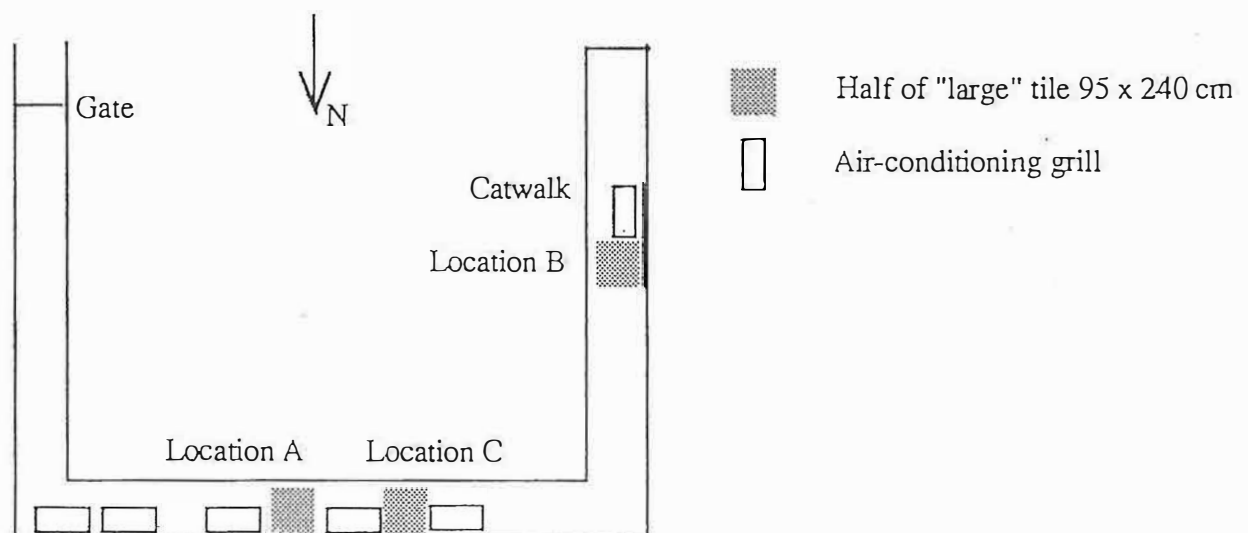
Diagram of Studio 21 Showing Tile Positions

The following diagrams show the approximate positions of the removed ceiling tiles.

All tiles were replaced with clear acrylic panels - glued into place with silicone adhesive, and the asbestos insulation was shielded from view by velcro attached fabric fitted to the underside of the T-bar ceiling grid.

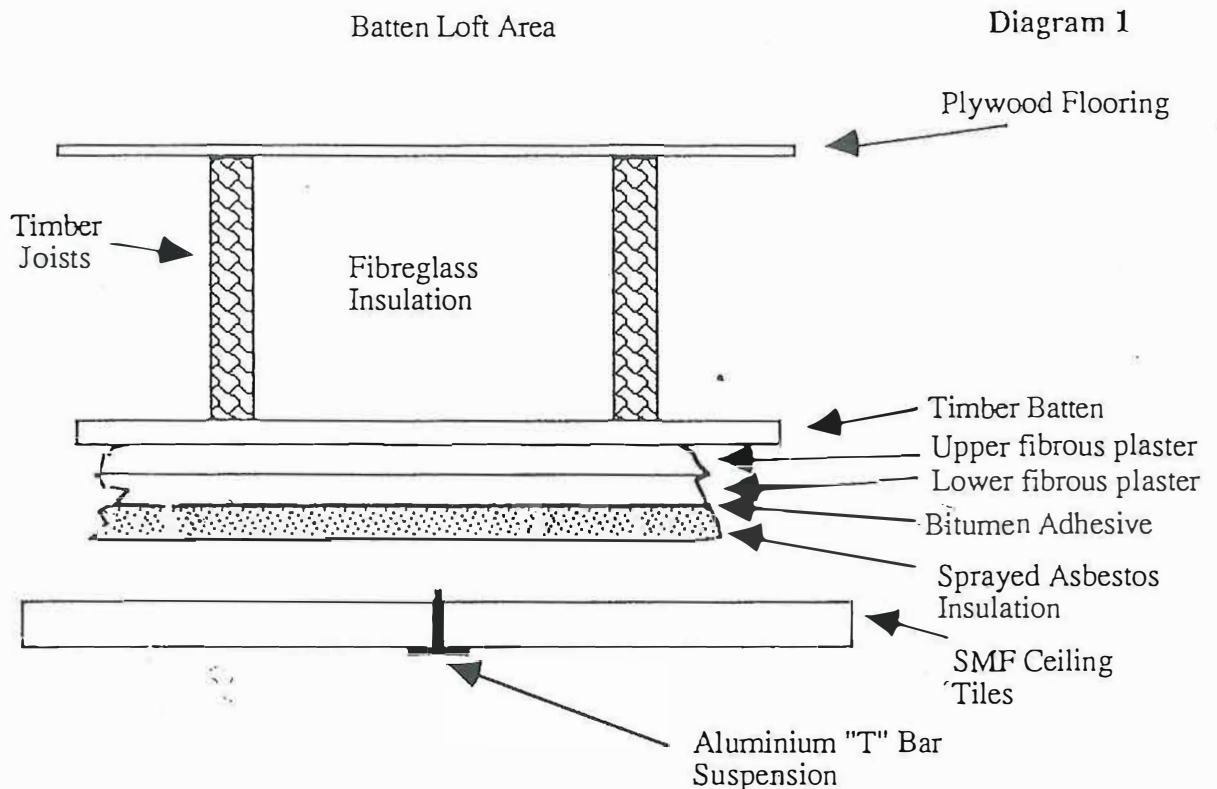
Diagram 1 is a cross-sectional representation of the soffit of the studio.

The asbestos insulation consists of amosite asbestos fibres (ie brown asbestos); varies from approximately 10 to 30 mm in thickness; and is strongly adhered to the lower surface of the lower of two layers of fibrous plaster with a bitumen based adhesive.

The asbestos insulation is very soft to the touch, and stereomicroscopic examination shows that there is very little of no internal adhesive throughout the insulation and that there is no evidence of any surface coating.

The under-surface of the insulation shows the presence of considerable mechanical damage caused most likely by past activities including suspension and tile installation.

Gross damage has occurred due to penetrations made in the past with ducts and steel support poles.
