## **Transportation Accident Paper:**

**Automobile Collision and Explosion  
Along Hwy 30 from Cuatrocienegas Site  
on September 9, 2007**

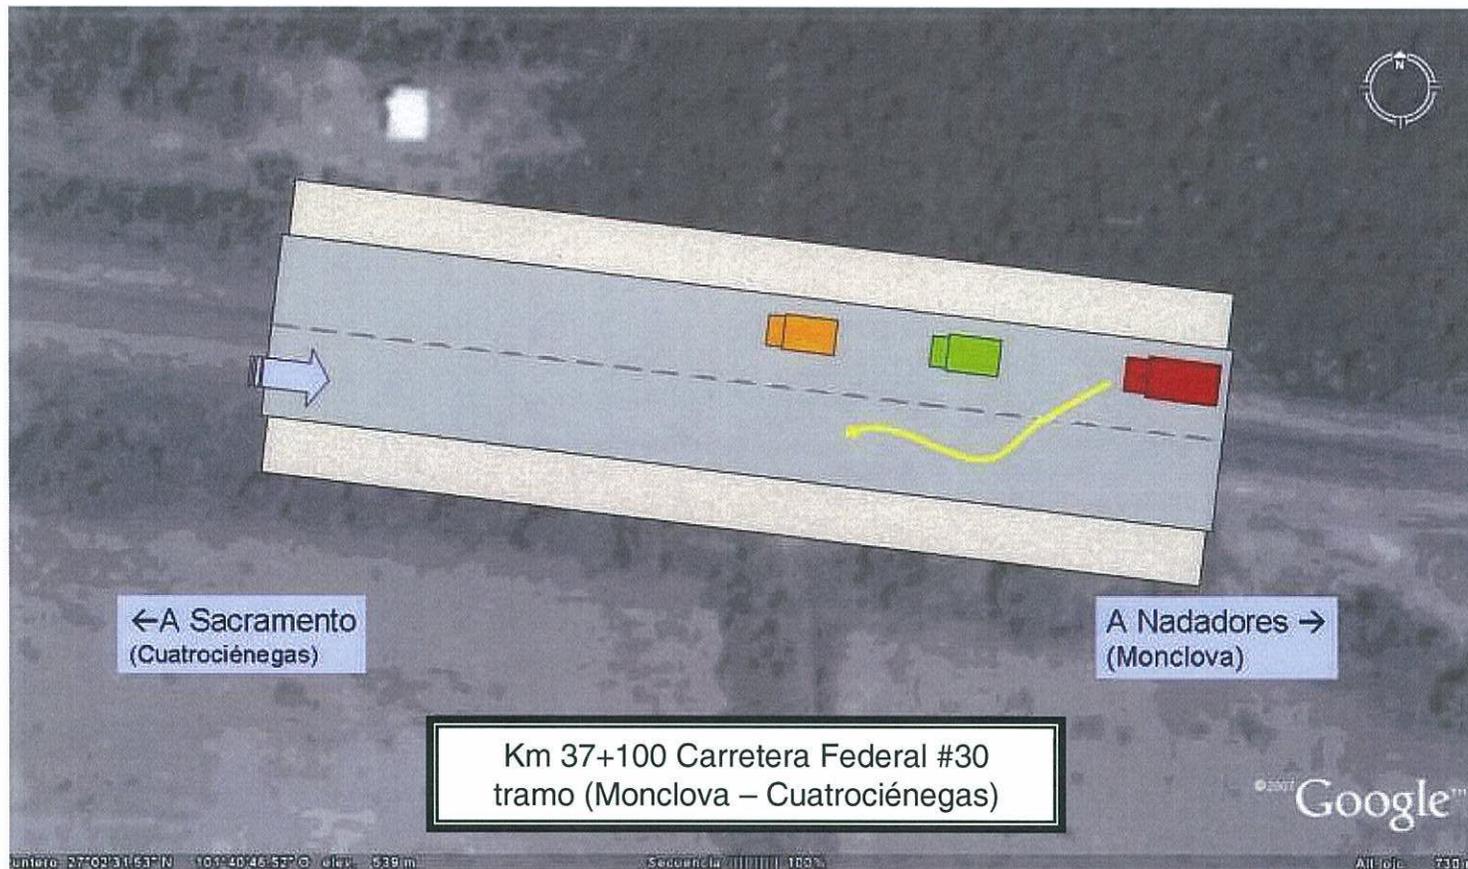
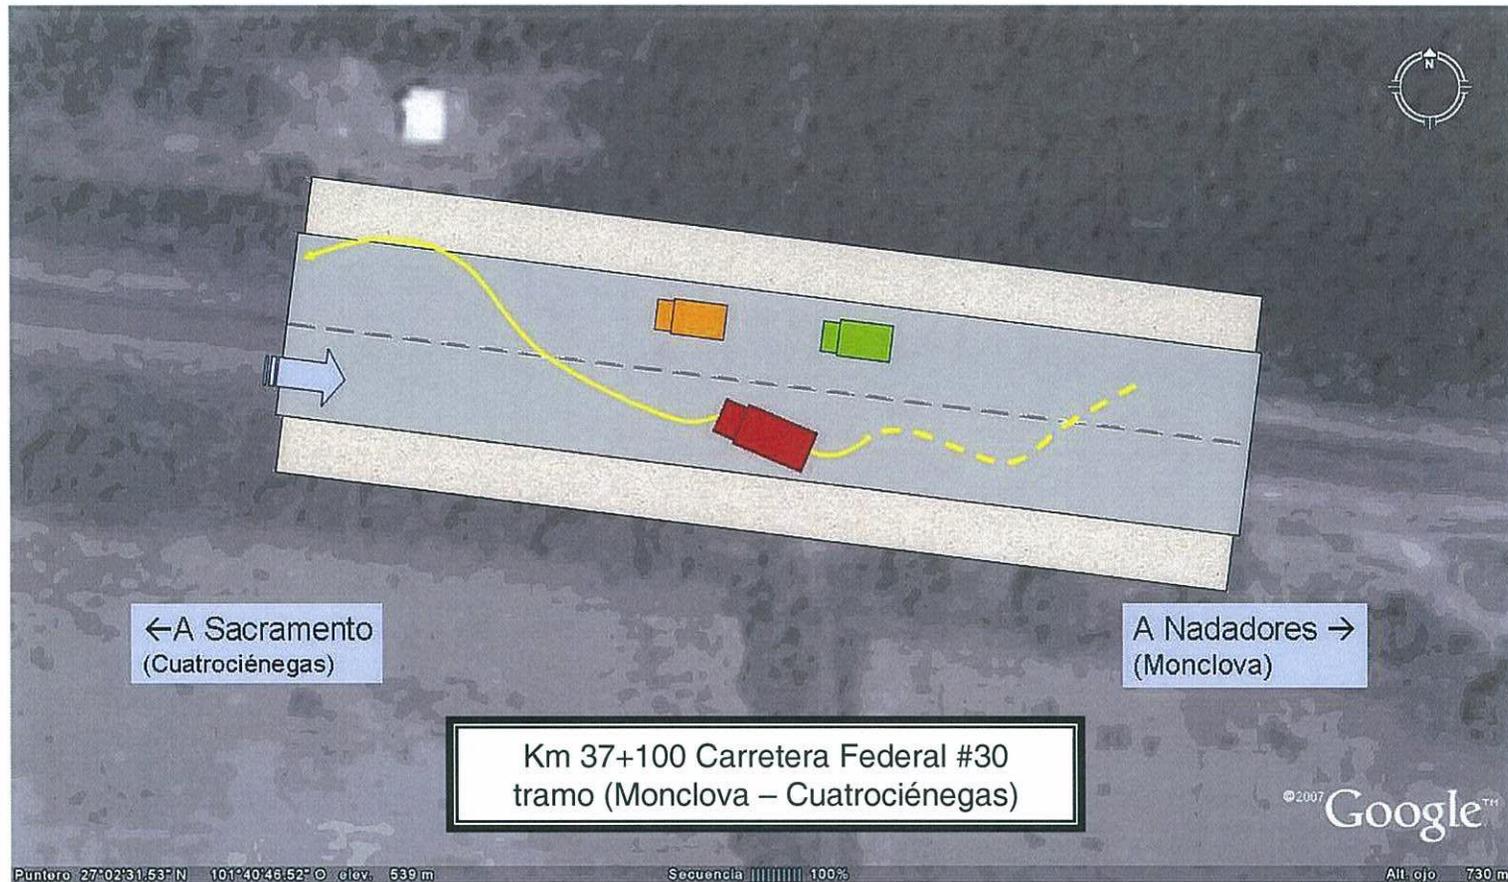
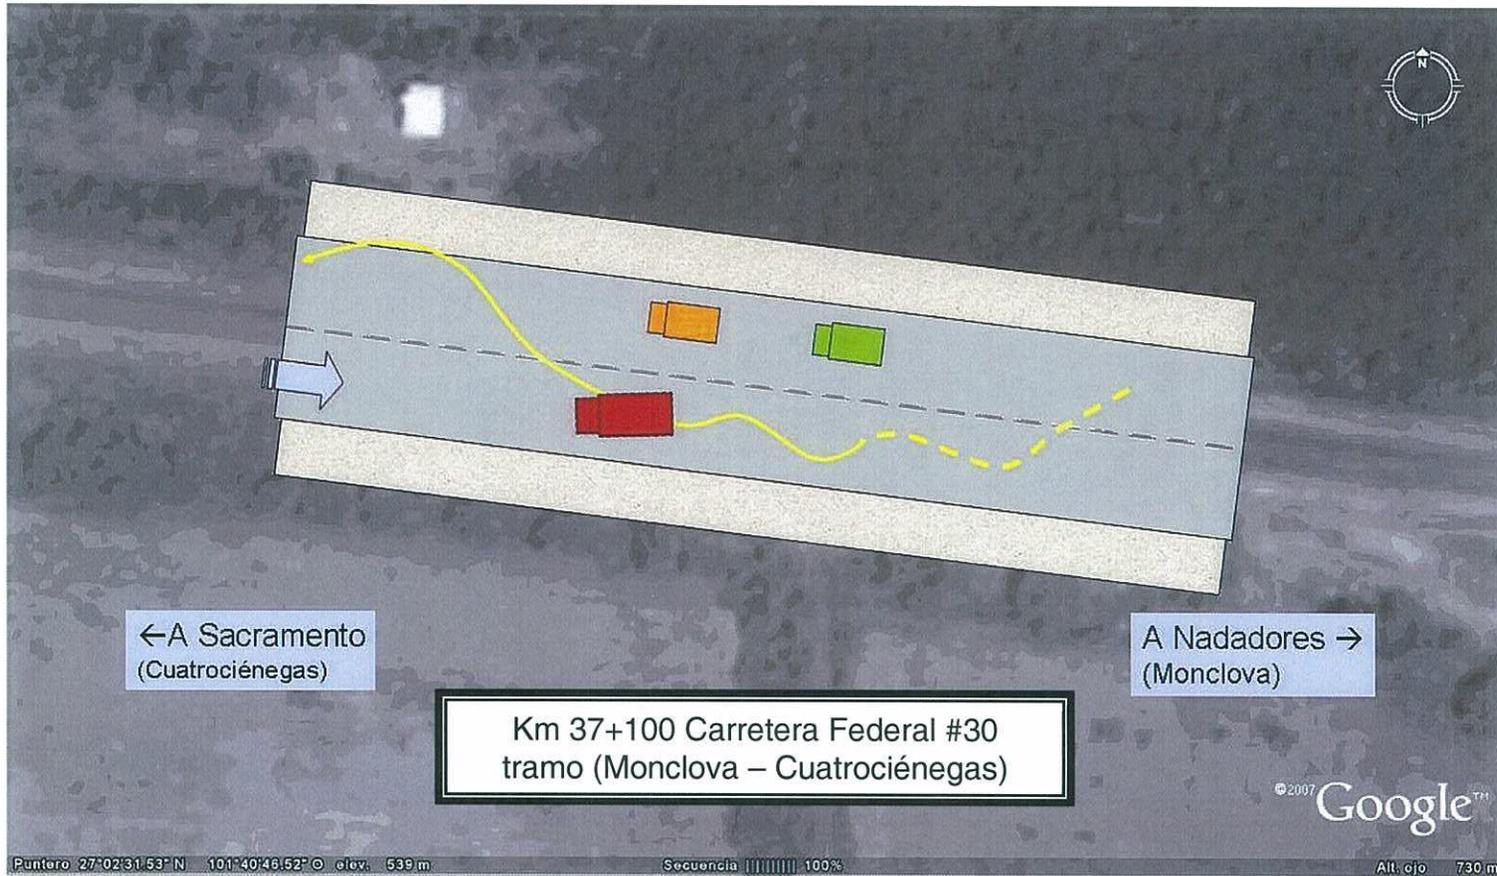
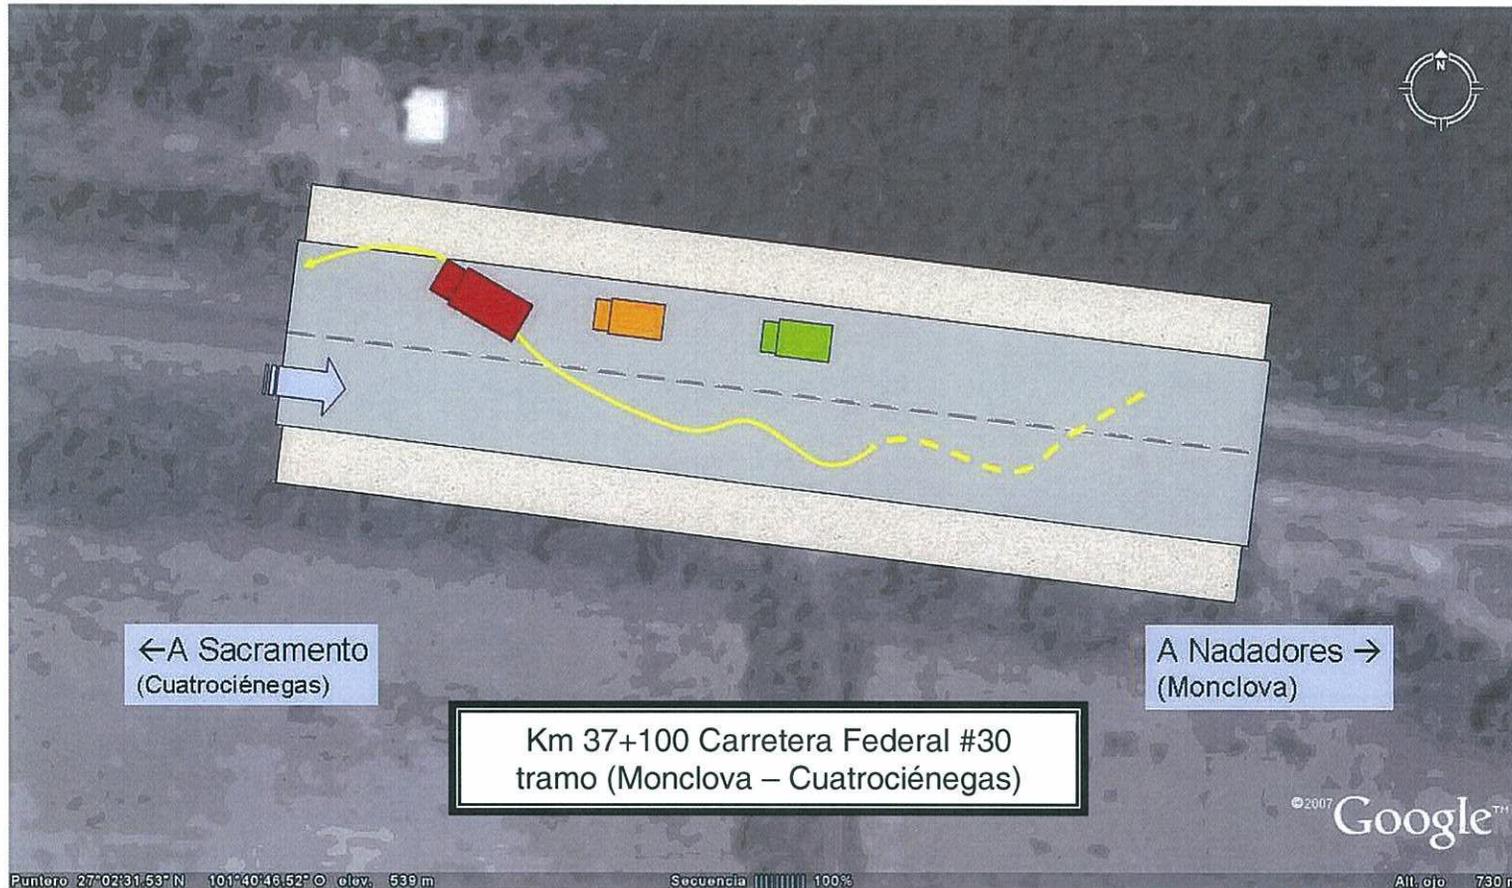
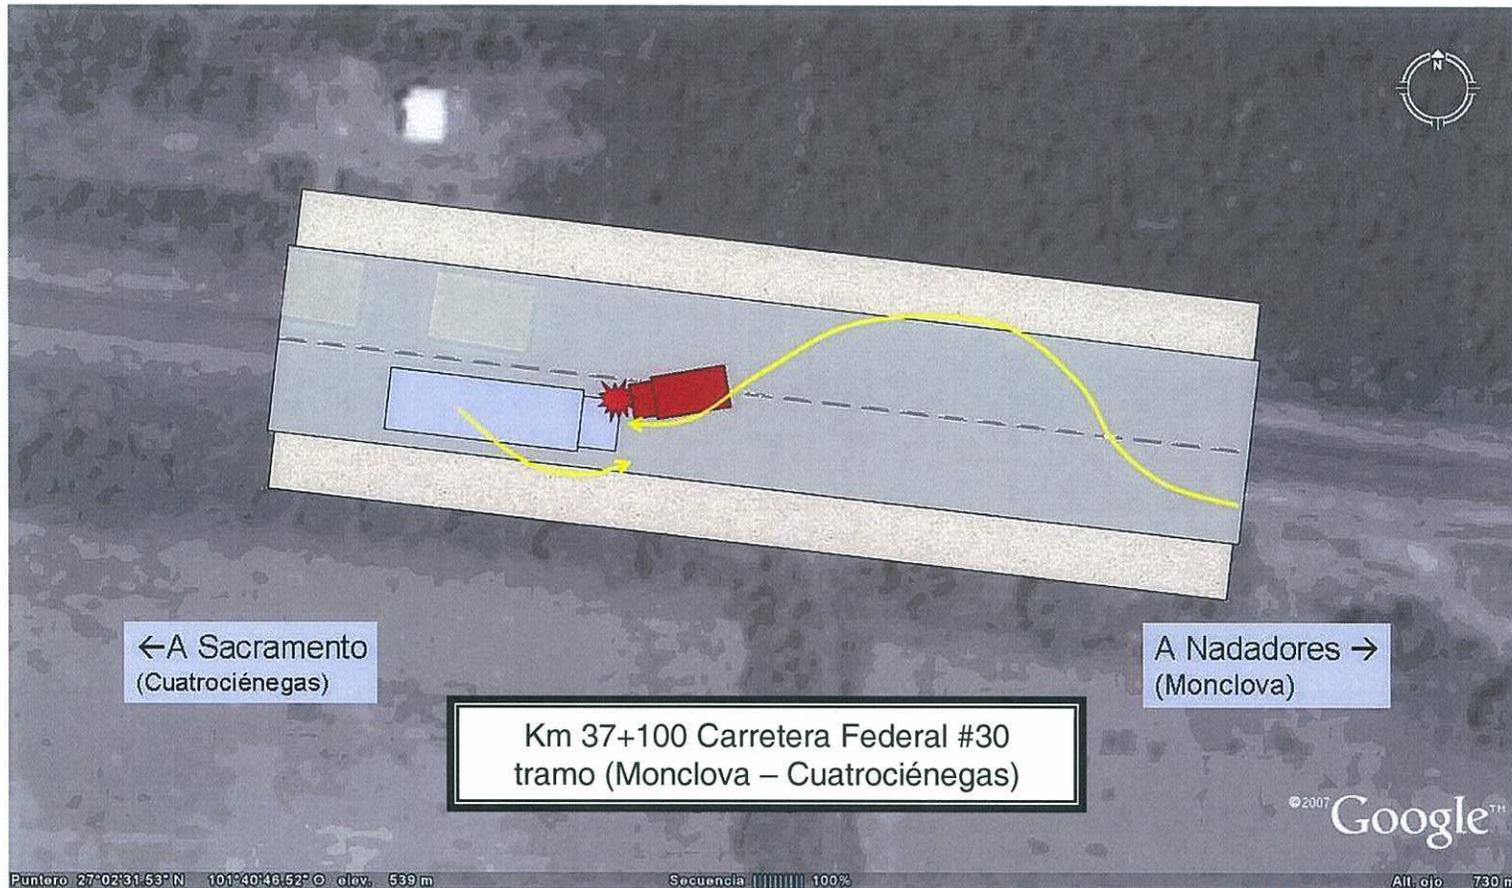
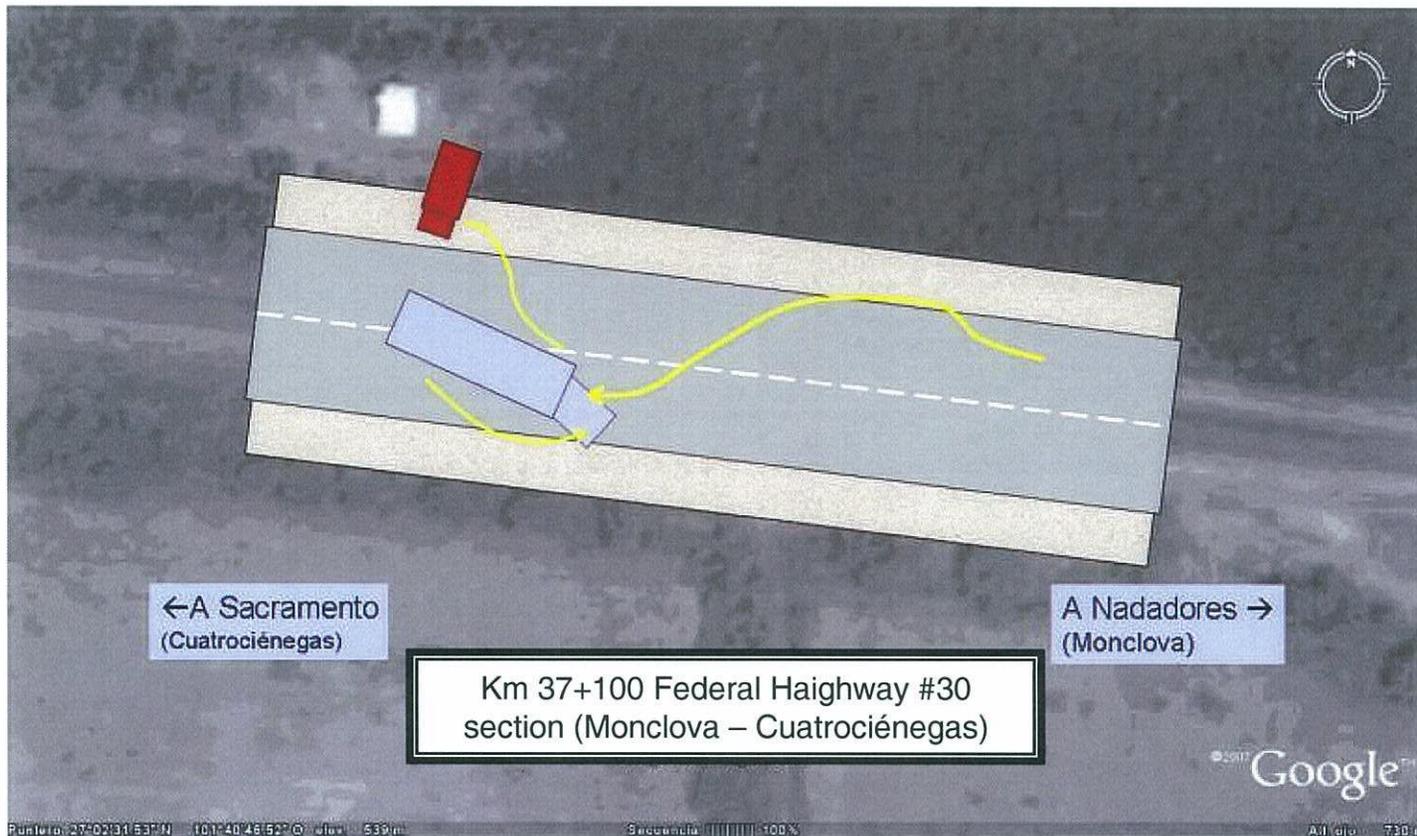
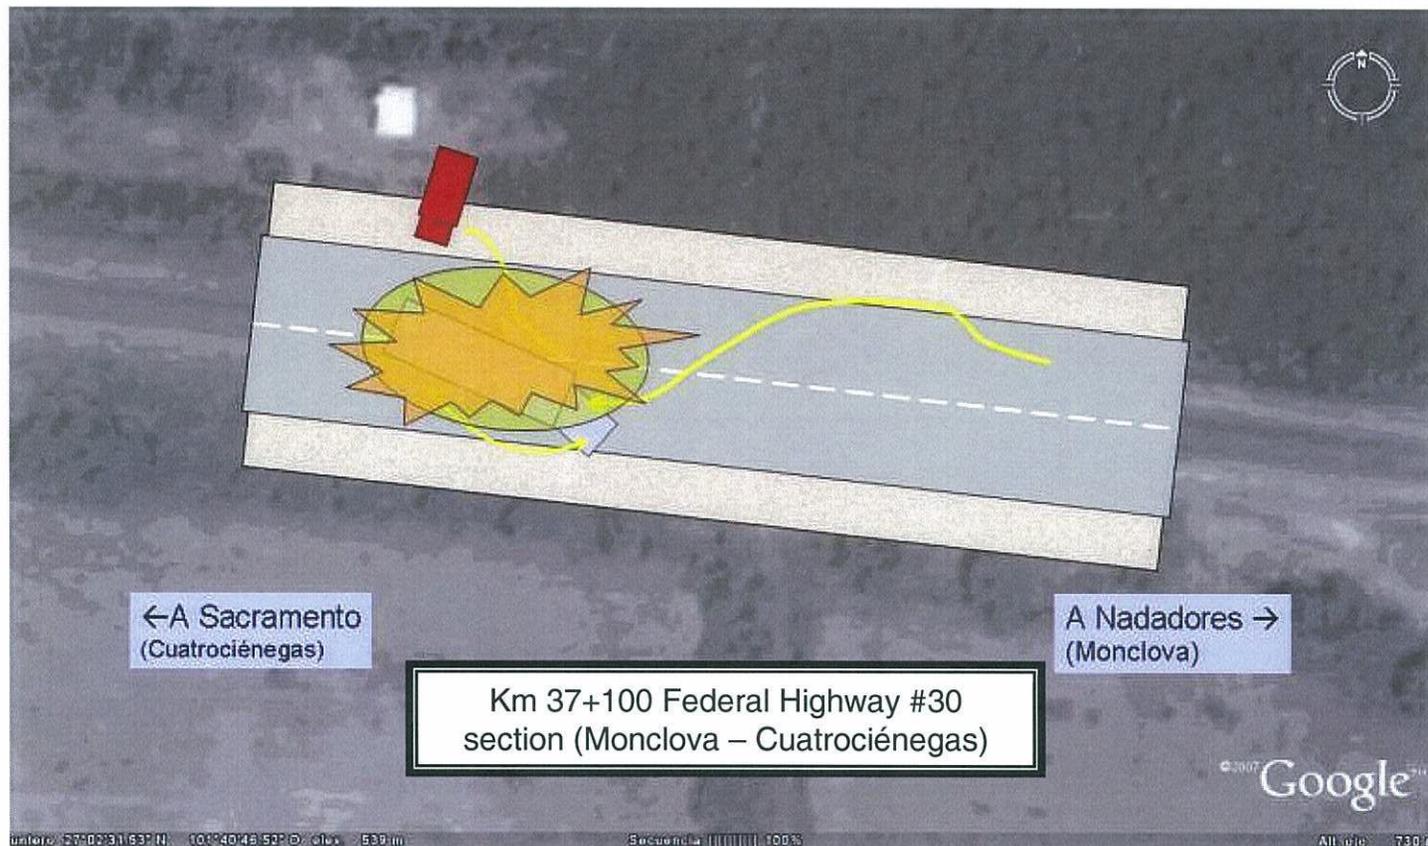
# Probable Sequence of the Incident

- A pickup truck, travelling in the opposite direction of the tractor-trailer transporting ANFO, loses control and enters the opposite lane colliding with the tractor trailer.
- This collision initiated a fire, which spread and resulted in an explosion ~ 43 minutes later

- **At about 8 PM local time:**
  - there is a collision of the vehicles and the fire begins.
- **Between 8 PM and 8:30 PM**
  - vehicles behind the tractor-trailer (eastbound) are stopped by the accident.
  - vehicles coming westbound from Monclova are stopped by an off-duty police officer.
  - bystanders from stopped traffic and nearby towns gathered at the accident site
- **At about 8:30 PM**
  - personnel from various emergency services arrive at the accident site to attend to the wounded. Journalists had also arrived
- **At about 8:43 PM**
  - the explosives product detonates

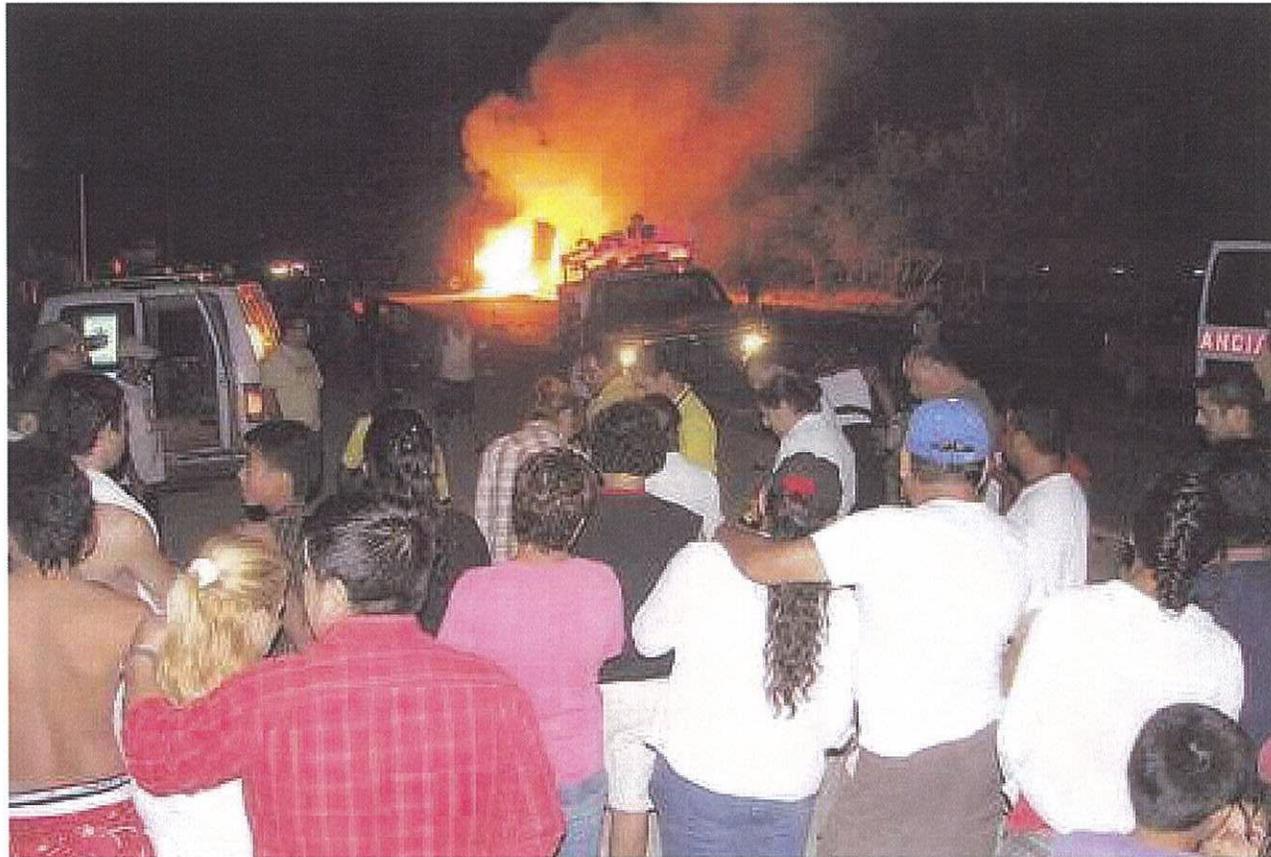
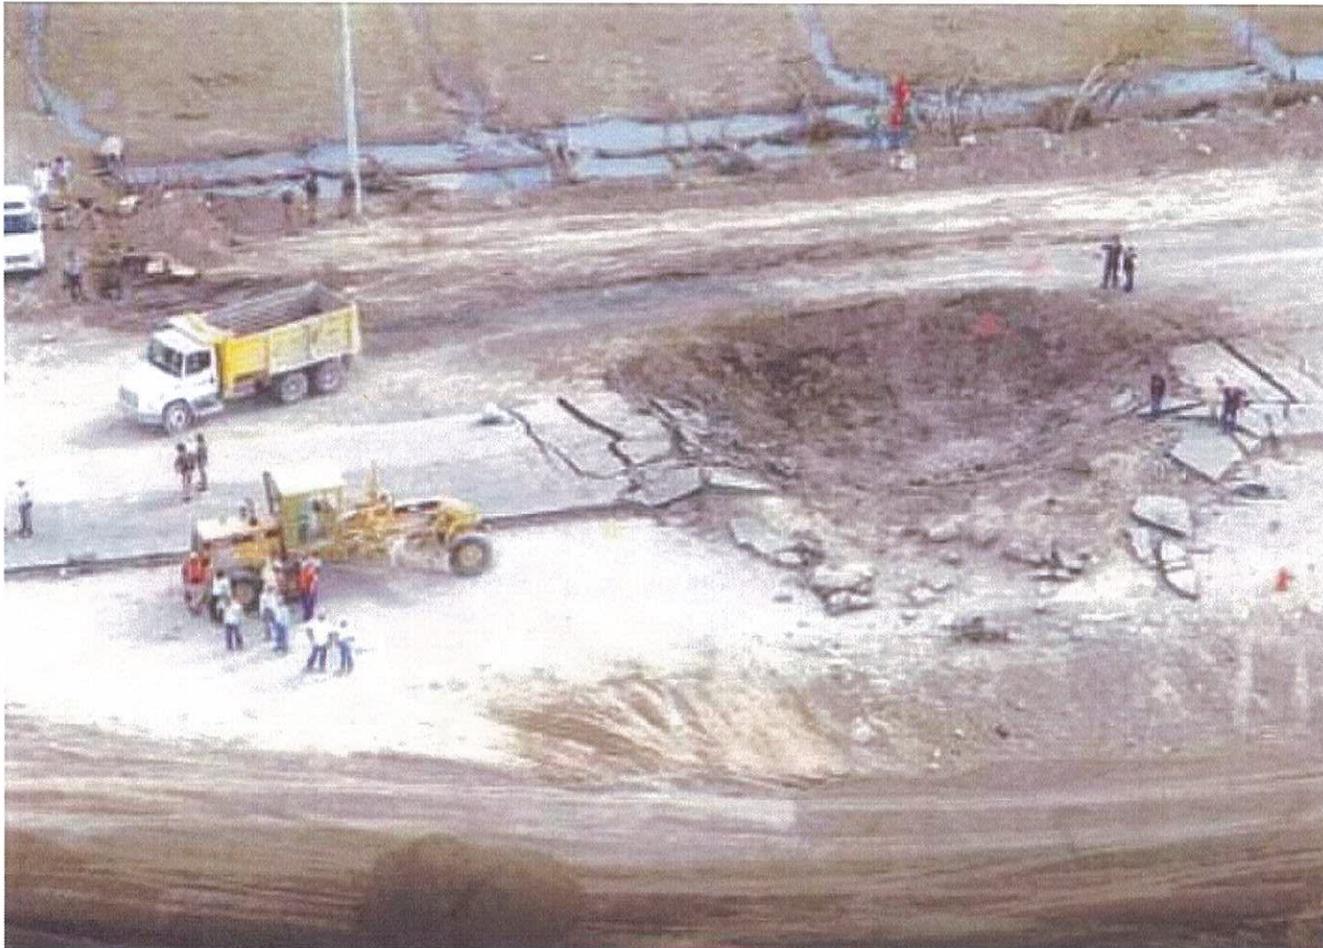
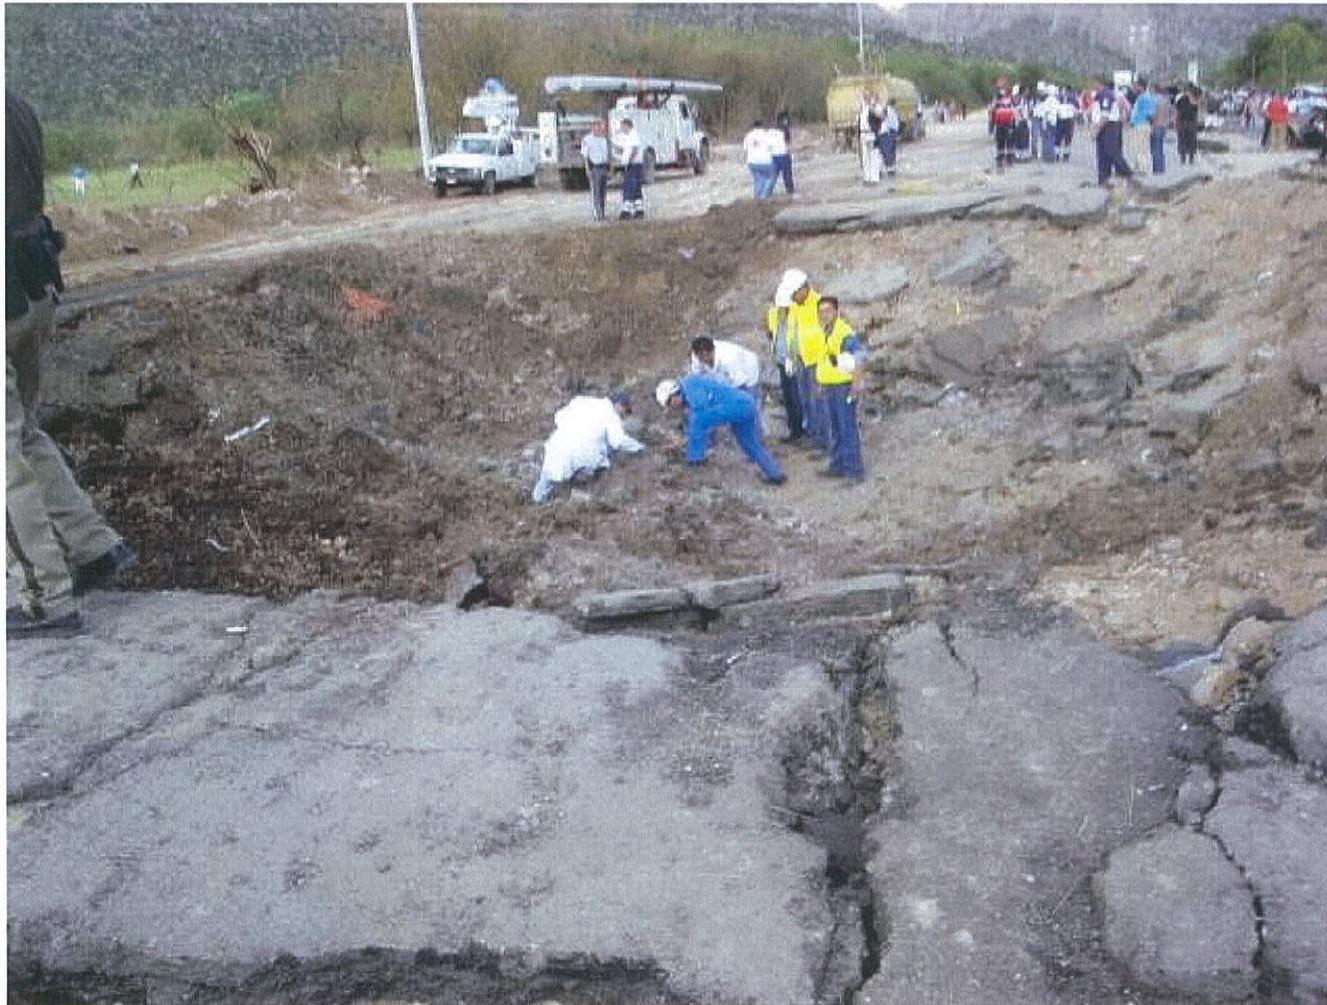
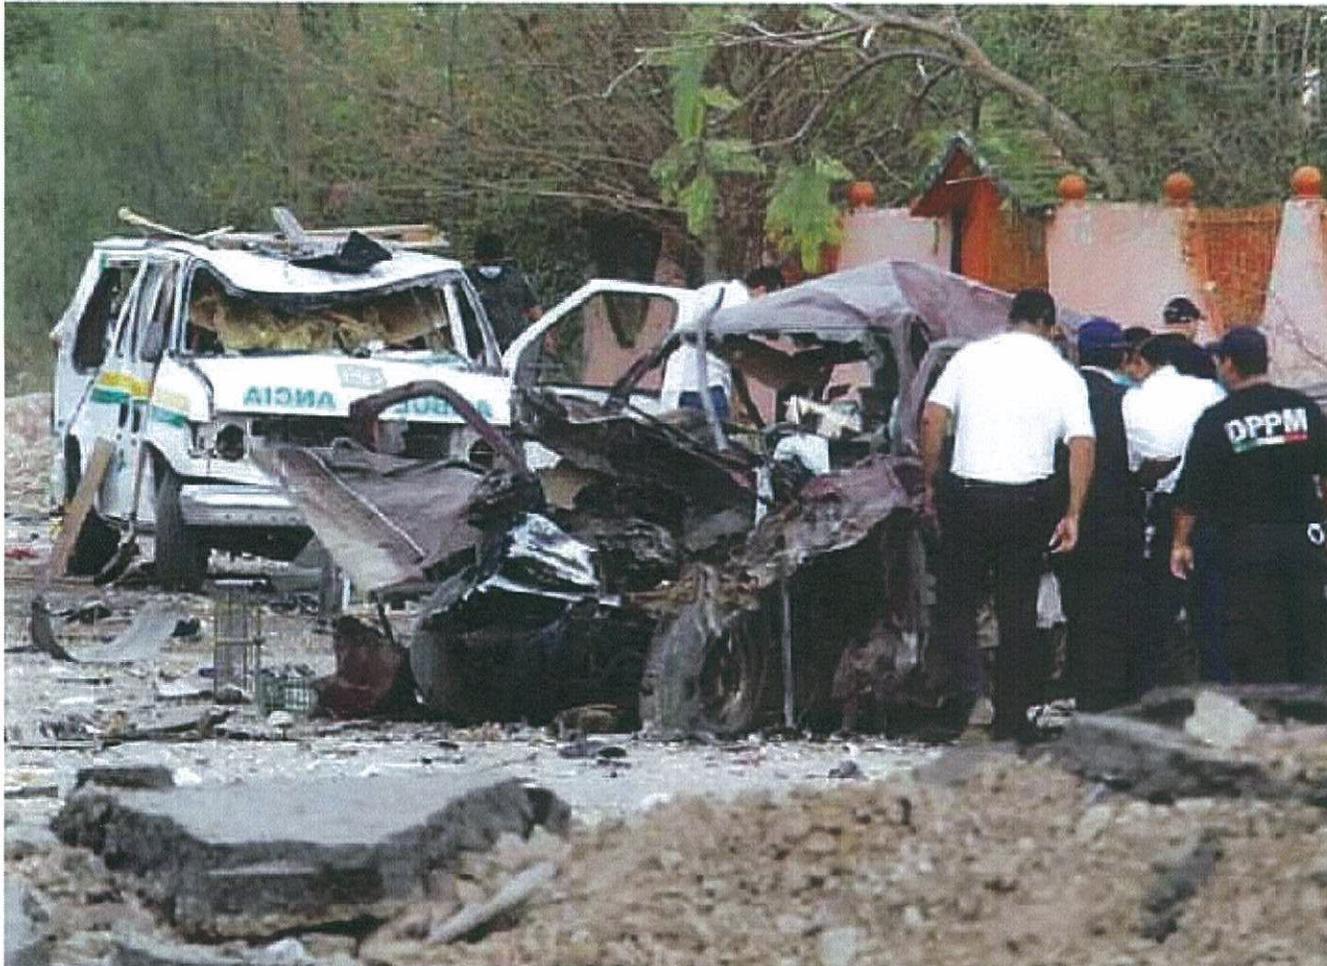
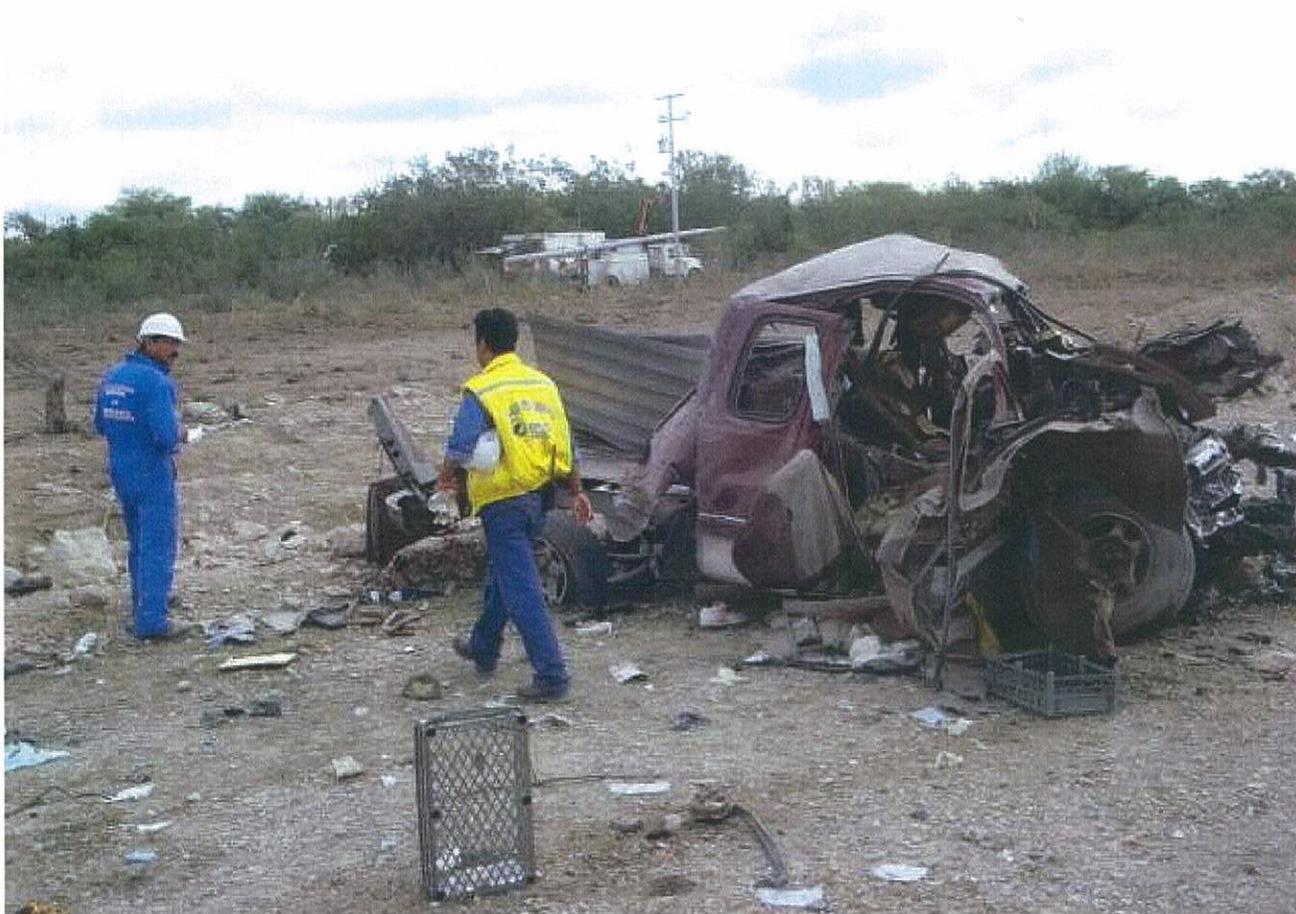
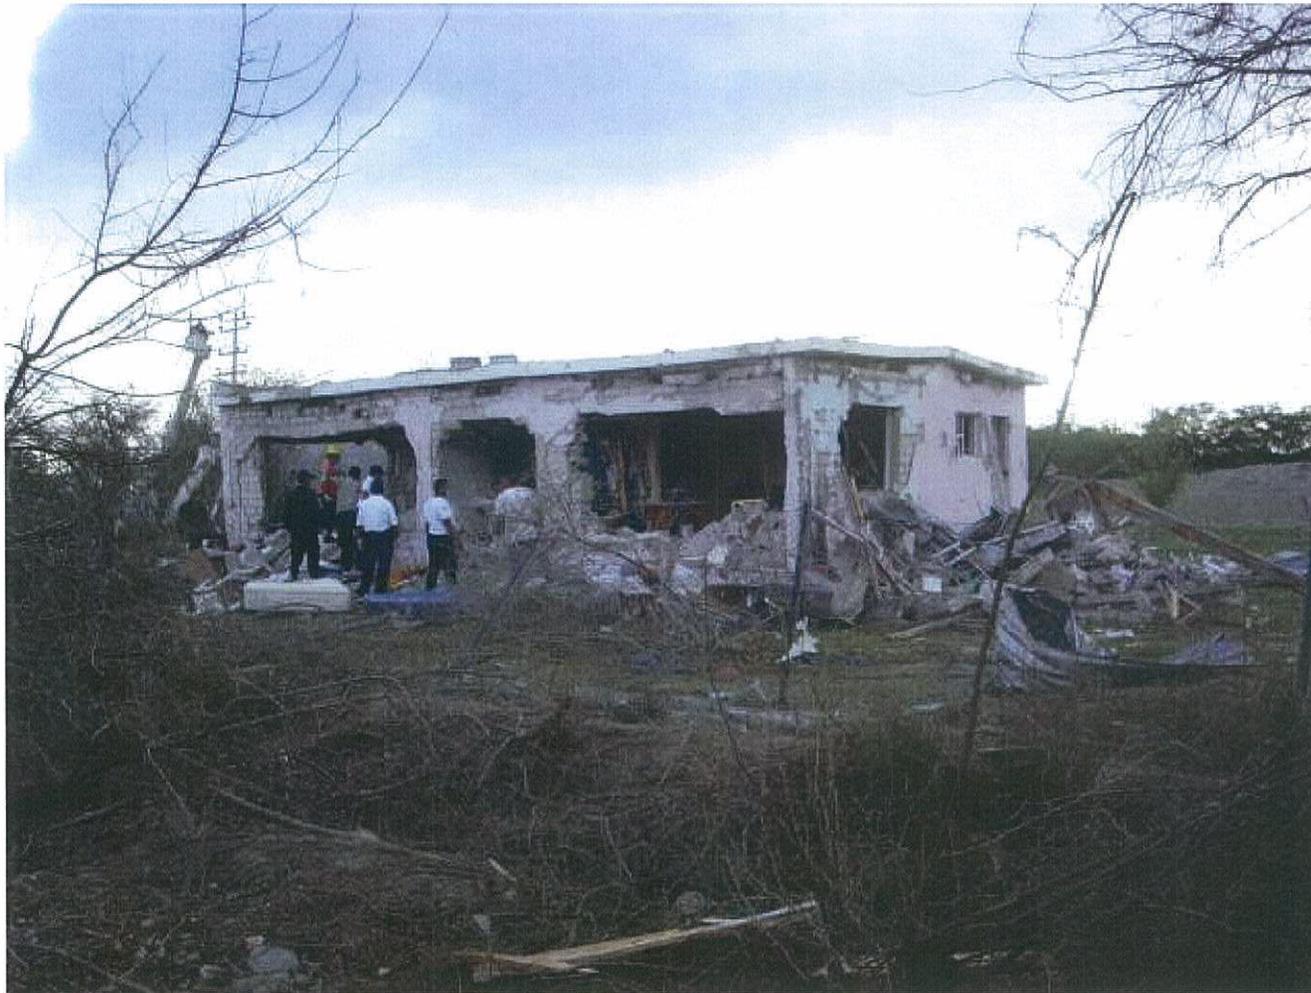
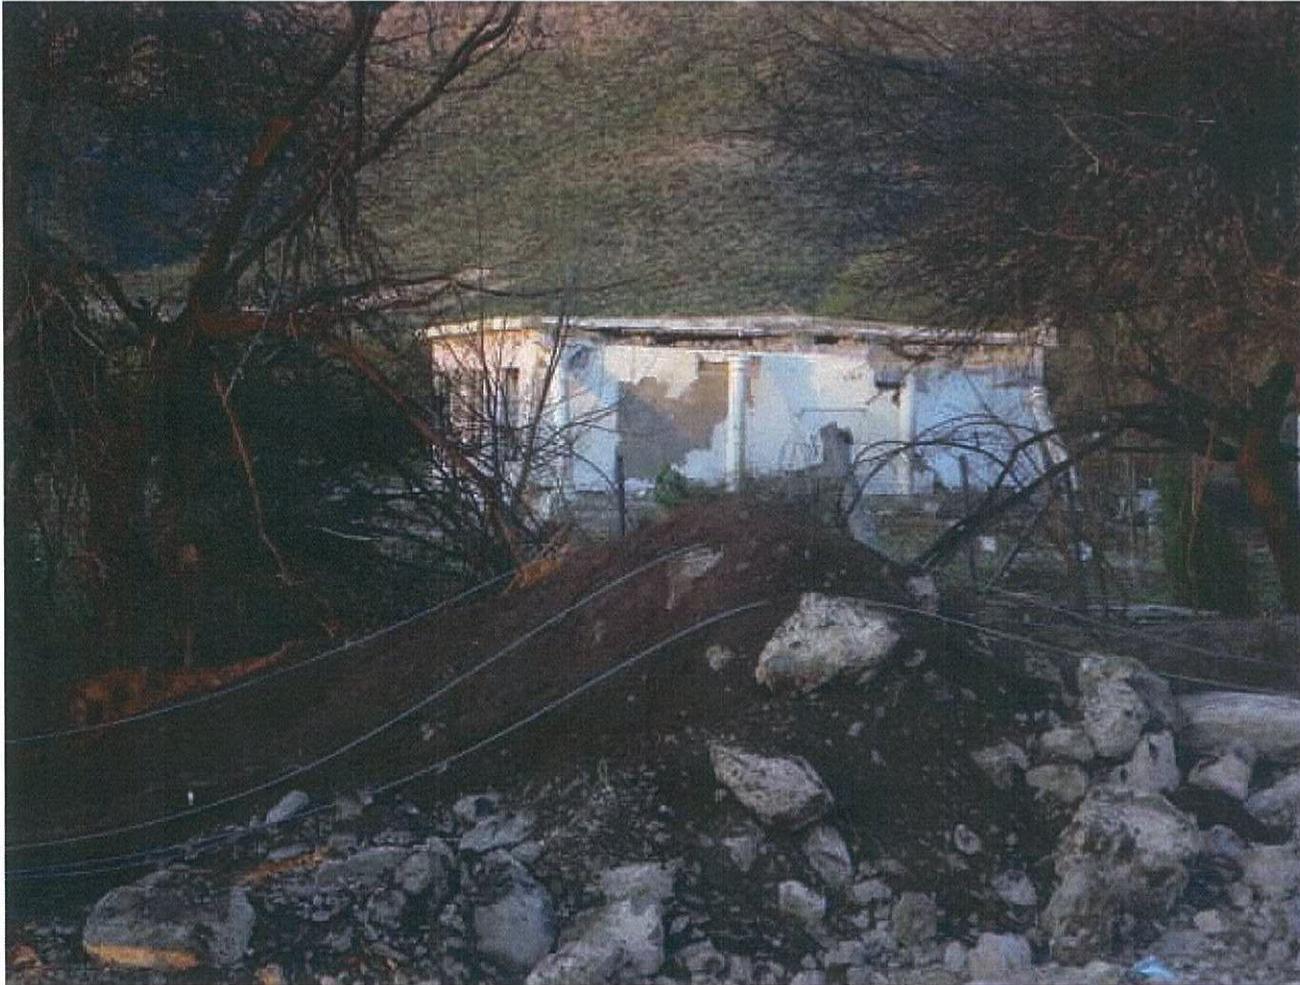
# Photos

- Total loss of tractor trailer transporting ANFO
- Total loss of the pickup truck which struck the tractor trailer
- At least 50 vehicles passing through the area with material damages
- 67 homes with structural damages within a radius of 1km (rural zone with low populations density)
  - 12 homes with serious damage (requiring rebuilding) and 55 with minor damages
- The detonation created a crater 20m diameter and 3m deep
- 350 people were evacuated from Celemania to Nadadores town
- Neighbourhood and public damage (houses, electrical poles, road, vehicles)

- Fire began in the cab area (driver statement)
- Fire spread to the trailer (Video footage)
- Fire burned for ~40 minutes (video clock)
- Exact cause of initiation of explosion is unknown
- Known Potential Sources of initiation
  - Tyres
  - Fuel Tank
  - Fire Extinguishers
  - Fire/heat (?)
