Coal Train Pollution Signature Study

*A briefing paper prepared by Associate Professor Nick Higginbotham,
Dr Ben Ewald, Ms Fee Mozeley and Dr James Whelan,*

August 2013

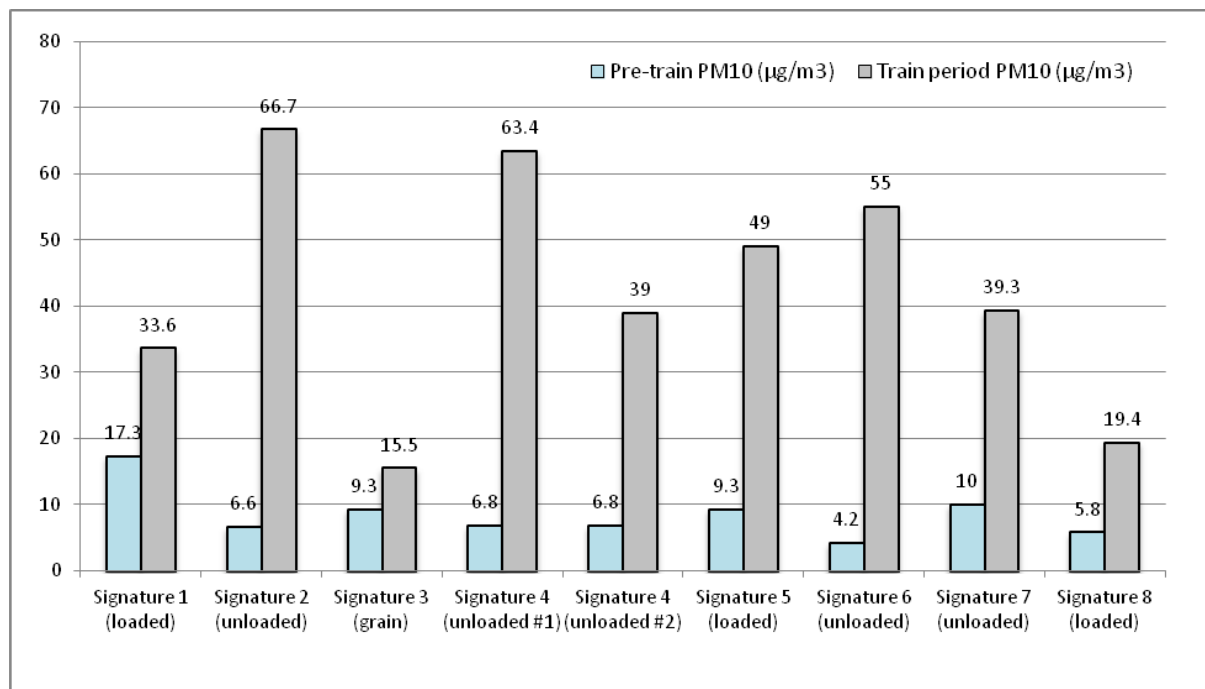
Chart 1: Particulate concentrations (PM₁₀) associated with train signatures

The following chart shows an analysis of particulate concentrations (PM_{10}) associated with each of the 8 signatures. It compares 2 minutes of pre-train air quality with 2 minutes of particulate matter concentrations produced during the train passage (i.e., the signature). All graphs show coal trains, apart from Signature 3, which is a grain freight train.

All coal train signatures were associated with a significant increase in PM₁₀ particle pollution levels. In the case of Signatures 1 and 5, this represents increases of 94% and 427% respectively for loaded coal trains. Signature 6 increased PM₁₀ concentrations significantly, up to 1210%. In sum, coal trains increase PM₁₀ levels by between 94% and 1210%. While coal trains pass, particle pollution concentrations increase up to 13 times pre-coal train levels.

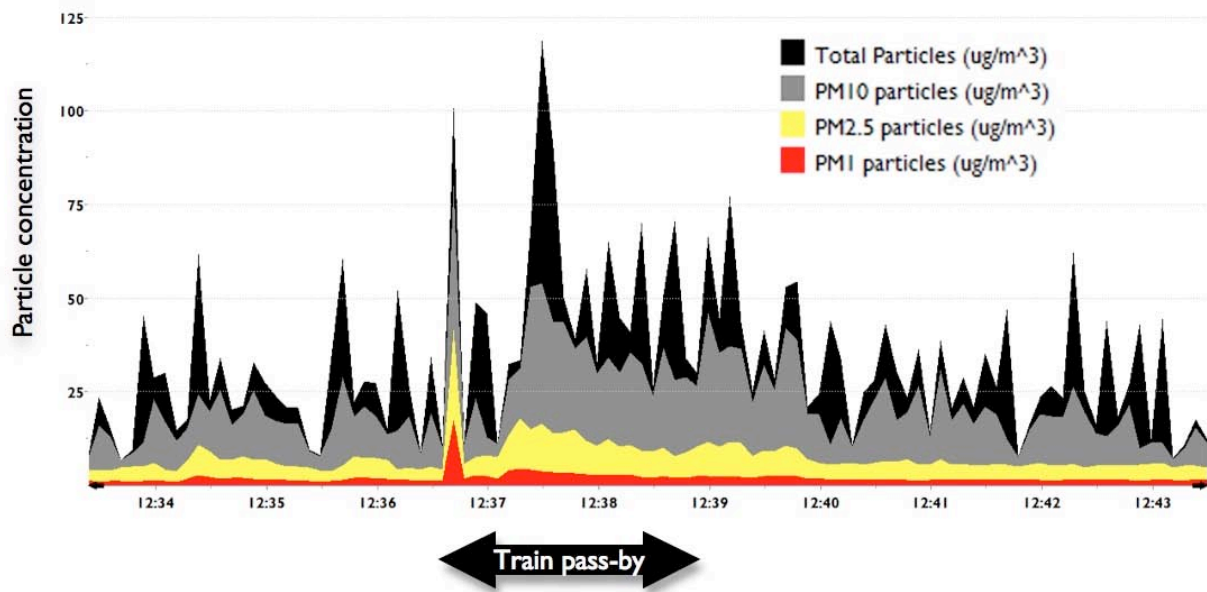
Figure 1. Signature 1 - Loaded Coal Train Monday 12:36pm

Signature 1 shows a characteristic loaded coal train (3 locomotives and 100 wagons) signature during monitoring. The train pass-by coincided with a brief wind blast of 3.6km/hr that was preceded and followed by relative stillness. The train slowed upon arrival to pass at an average of 42km/hr.

The loaded coal train produced a sharp rise in concentrations of all particulate sizes and produced an entrainment that lasted more than four minutes. This signature stands out against background track air that had residual pollution from an earlier train that had passed by less than two minutes prior.

The short burst of PM₁, PM_{2.5} and PM₁₀ at the onset of the pass by is remarkable. The high ratio of PM₁ to TSP indicates diesel emissions and is positively correlated with the logged observations that noted that this train was producing ‘heavy smoke’ from the locomotives.

This signature shows continuing high proportions of PM₁₀ to TSP, with a gradual decline in PM_{2.5}, and a slow return to pre-train background levels. PM₁₀ was 33.6µg/m³ averaged over two minutes and pre-train background PM₁₀ levels were 17.3µg/m³.

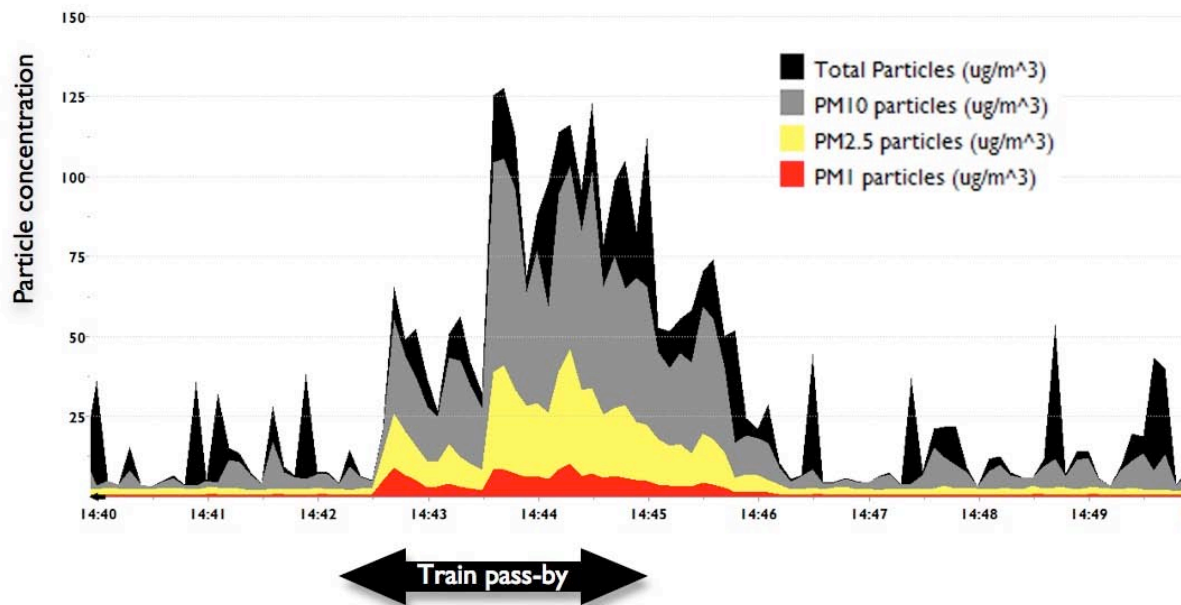
Figure 2. Signature 2 - Unloaded Coal Train Monday 14:42pm

Signature 2 is indicative of an unloaded coal train pass-by. The track for this unloaded coal train was the closest to the Osiris monitor. Unloaded coal trains generally approached the monitor at higher speeds than loaded coal trains. This unloaded coal train (with 3 locomotives and 98 wagons) slowed to an average speed of 35km/hr. The wind was moving at 0.13km/hr and turned from N to the direction of the train, which was SE/SSE during the pass-by.

This signature shows two initial spikes in particulate matter with a one minute delay and then a third, larger and more sustained pollution plume. Signature shows a strong indication of diesel emissions (PM_{10}) and strong $PM_{2.5}$ levels accompanying the high levels of PM_{10} . The two-minute average of PM_{10} was $66.7\mu\text{g}/\text{m}^3$ compared to the two minute average pre-train level of $6.6\mu\text{g}/\text{m}^3$. An entrainment of more than four minutes is noted.

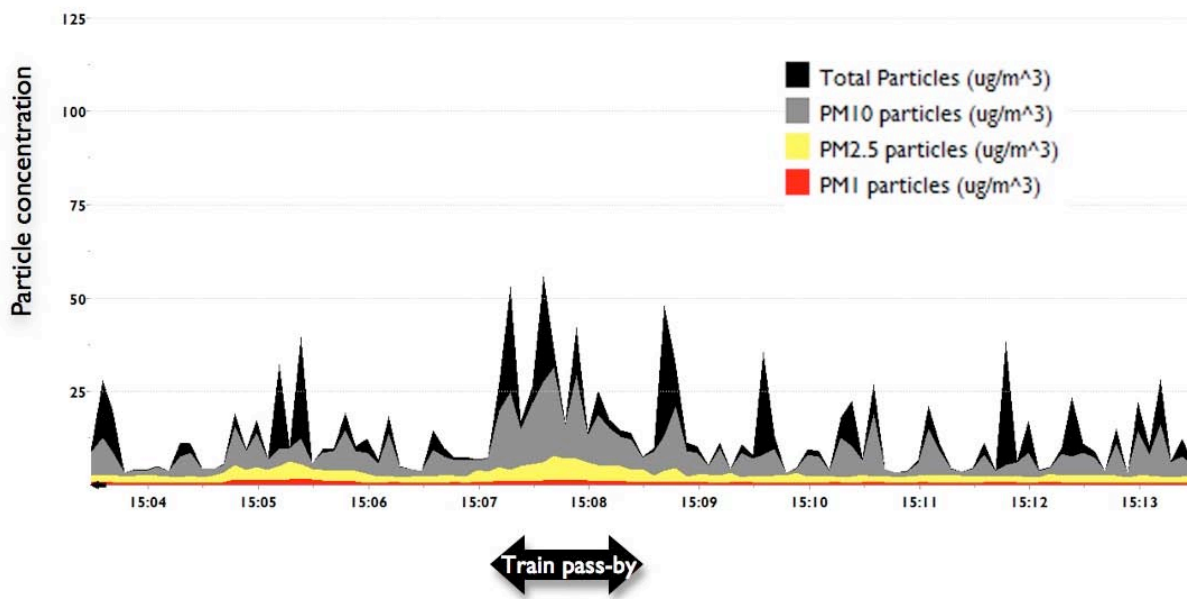
Figure 3. Signature 3 – Grain Train Monday 15:07pm

Signature 3 represents the affects of a freight train carrying grain. This AWB grain train (with 4 locomotives and 36 enclosed wagons) was travelling on the track closest to monitor. The train was moving at an average speed of 31km/hr. The air was still and the blast of air that accompanied the train changed the wind direction from NNE to SE during the pass-by. It gives a modest signature against the background, with two-minute average PM_{10} levels of $15.5\mu\text{g}/\text{m}^3$ and average pre-train background levels of $9.3\mu\text{g}/\text{m}^3$.

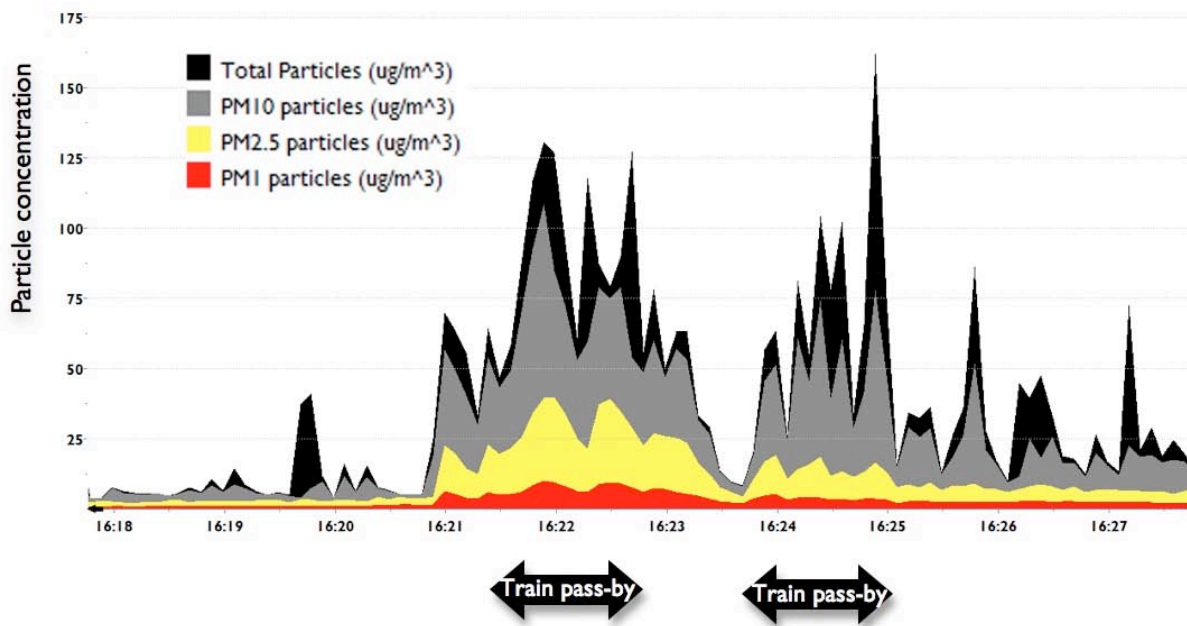
Figure 4. Signature 4 – Multiple Unloaded Coal Trains Monday 16:21pm

Signature 4 captures two back-to-back unloaded coal trains. The first unloaded coal train (3 locomotives and 104 wagons) approached at 69km/hr and then slowed to an average speed of 40km/hr. The second unloaded coal train (2 locomotives and 72 wagons) passed by at a constant speed of 67-68km/hr. The combination of the two trains generated their own wind, increasing from 1.9 to 4.3km/hr (ESE).

The signature shows high levels of TSP containing PM₁₀ and high initial levels of PM_{2.5} that is slow to diminish. The first train PM₁₀ level was 63.4µg/m³ while the pre-train level was 6.8µg/m³. The second train measured an average PM₁₀ level of 39µg/m³.

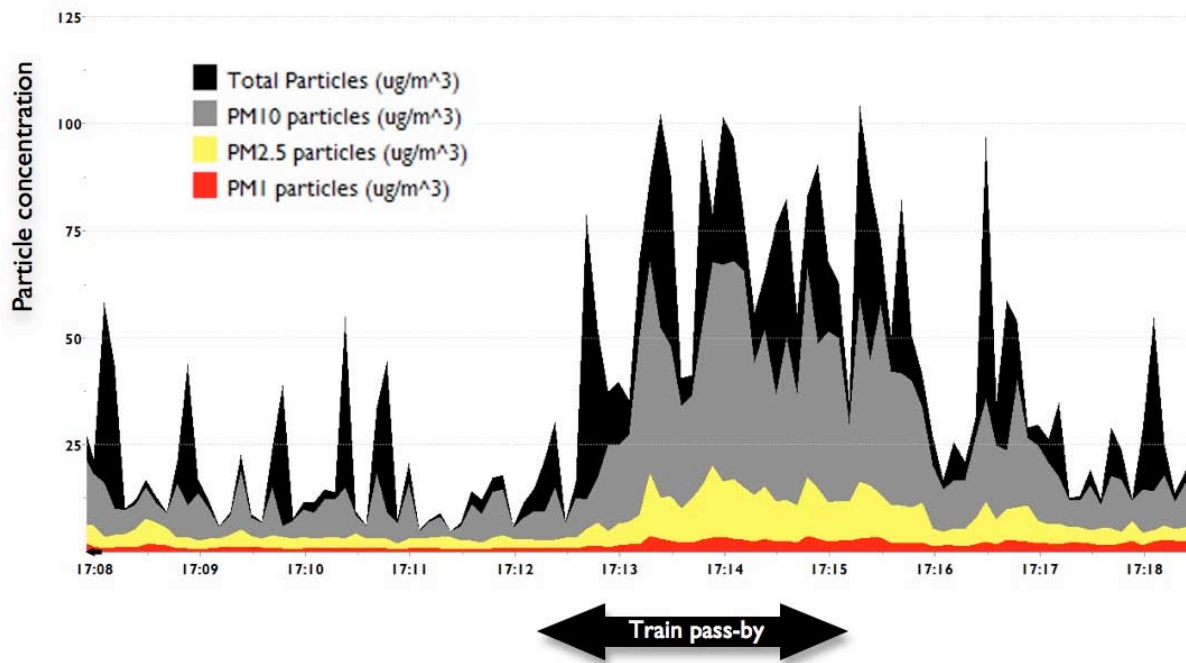
Figure 5. Signature 5 – Loaded Coal Train Monday 5:12pm

Signature 5 shows a loaded train (3 locomotives and 92 wagons) travelling at an average speed of 29km/hr. The wind speed was 0.7km/hr from the NNW, following the train. This signature was capture at the end of the first day of monitoring. Wind conditions were very still. The loaded coal signature is evident against increased background pollution levels from previous trains.

This signature shows a delay in plume arrival carrying a large proportion of PM₁₀ with a long entrainment. A 30 second gap was added to adjust for plume delay, two minute average of train pass-by measured PM₁₀ at 49µg/m³ and two minute average for pre-train background levels at 9.3µg/m³.

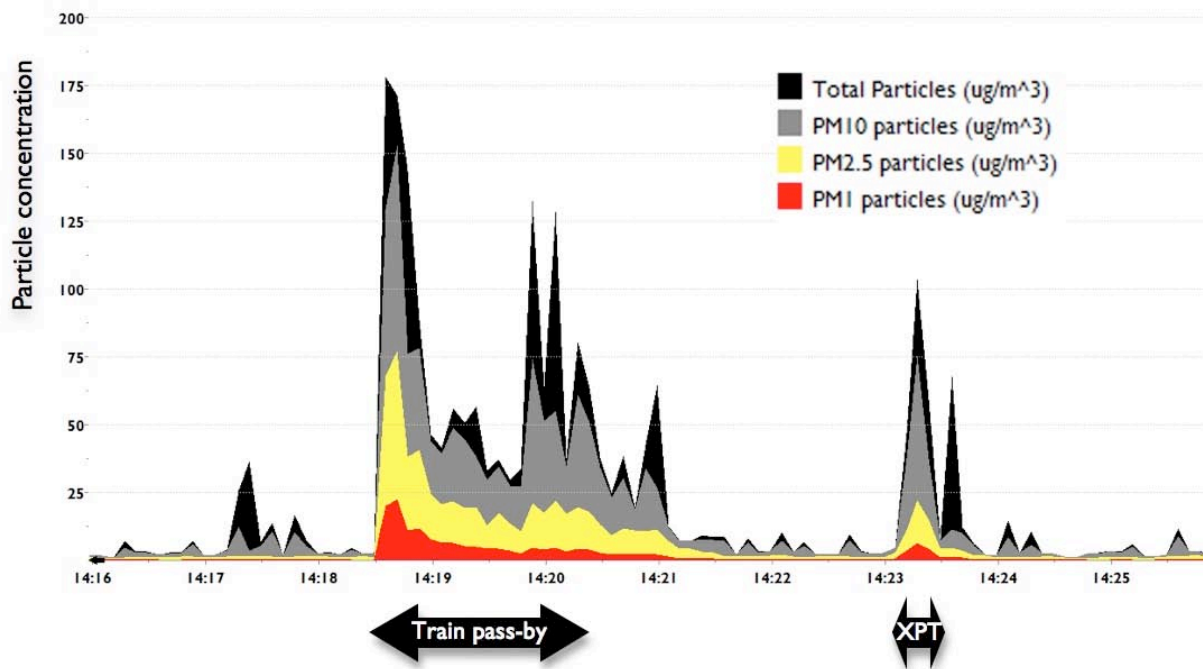
Figure 6. Signature 6 – Unloaded Coal Train Tuesday 2:18pm

Signature 6 was termed the ‘Midnight Oil’ signature by an atmospheric scientist in honor of the band’s 1987 hit album ‘Diesel and Dust’. The unloaded coal train (3 locomotives and 82 wagons) approached the monitoring site travelling at 59km/hr and was heading into a NW 7.9km/hr wind. Logged observations noted that billowing smoke could be seen from the locomotives as the train approached and that the smell of diesel was distinguishable at the onset of the train pass-by.

The signature shows that the initial plume contained high concentration of PM₁ indicating diesel combustion. The wind speed was significantly stronger and this may account for the absence of a delay in the arrival of the initial pollution plume and also for the rapid dispersion of particulates back to baseline in less than three minutes. Average PM₁₀ for the train pass-by was measured as 55µg/m³ and pre-train average was 4.2µg/m³.

In the wake of the ‘Midnight Oil’ train described above, a fast moving XPT CountryLink train was captured. This train produced a clear signature of very short duration, evident toward the right side of figure 6 above. This signature shows a diesel combustion spike and high proportion of PM₁₀, followed by a second short dust burst.

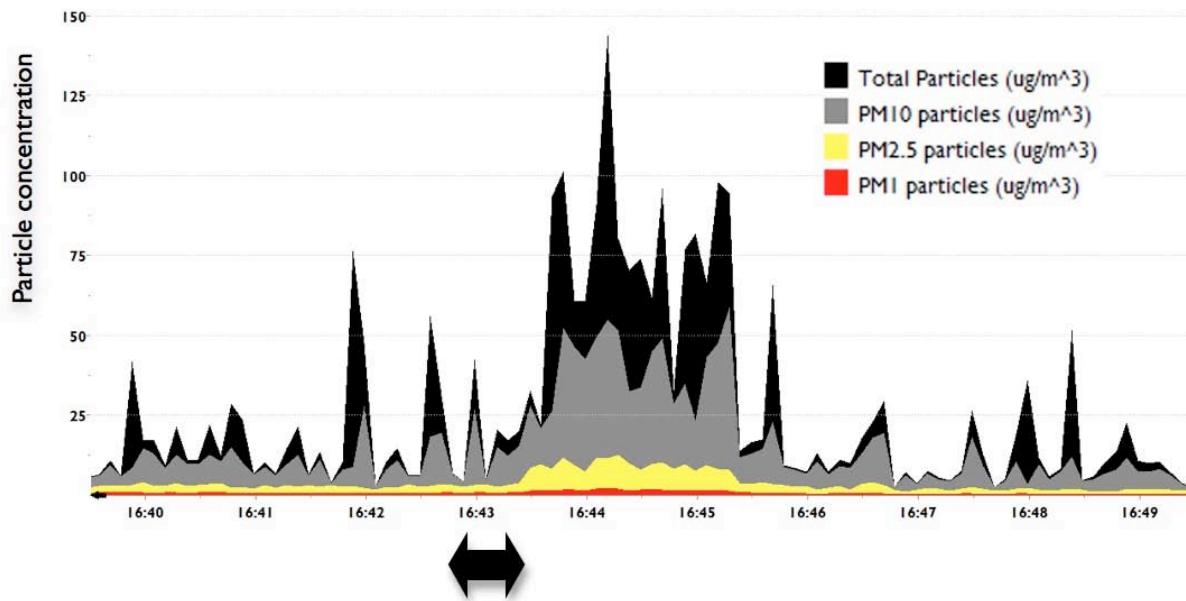
Figure 7. Signature 7 – Unloaded Coal Train Tuesday 16:42pm

Signature 7 corresponds to a fast unloaded coal train (2 locomotives and 39 wagons) captured at Hexham on Tuesday. Initial train speed was calculated as 71km/hr with an average pass-by speed of 57km/hr. There was no wind during the pass-by.

The signature shows that the train had almost completely passed by before the pollution plume registered. The signature depicts high levels of PM₁₀ and TSP and shows a relatively fast return to baseline levels. Two-minute averages of PM₁₀ during train pass-by were measured as 39.3µg/m³ and two minute pre-train background PM₁₀ levels were 10µg/m³.

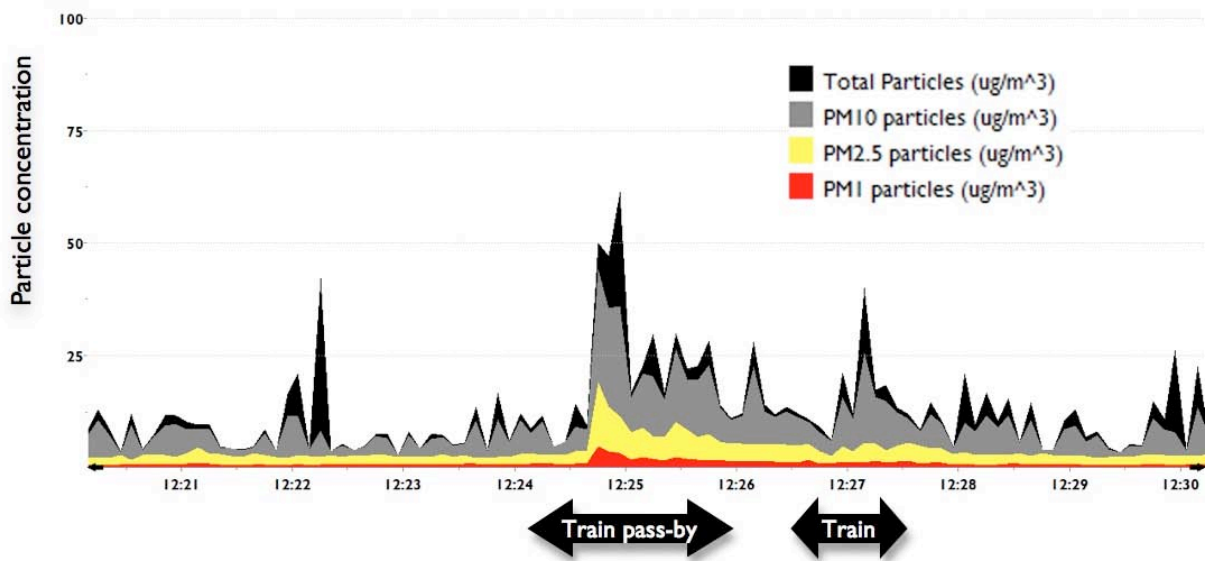
Figure 8. Signature 8 – Loaded Coal and Freight Trains Wednesday 12:24pm

Signature 8 is a loaded coal train (3 locomotives and 96 wagons) captured at Beresfield on Wednesday. This train moved at a steady pace averaging 46km/hr. Wind speed was 4.4km/hr and followed the train from a NNW direction.

This signature is modest. TSP peaks at $63\mu\text{g}/\text{m}^3$. High concentrations of PM_{10} are observed and there is a clear rise in PM_1 and $\text{PM}_{2.5}$. A 30 second gap was added to adjust for plume delay, two minute average of train pass-by measured PM_{10} at $19.4\mu\text{g}/\text{m}^3$ and two minute average for pre-train background levels at $5.8\mu\text{g}/\text{m}^3$.

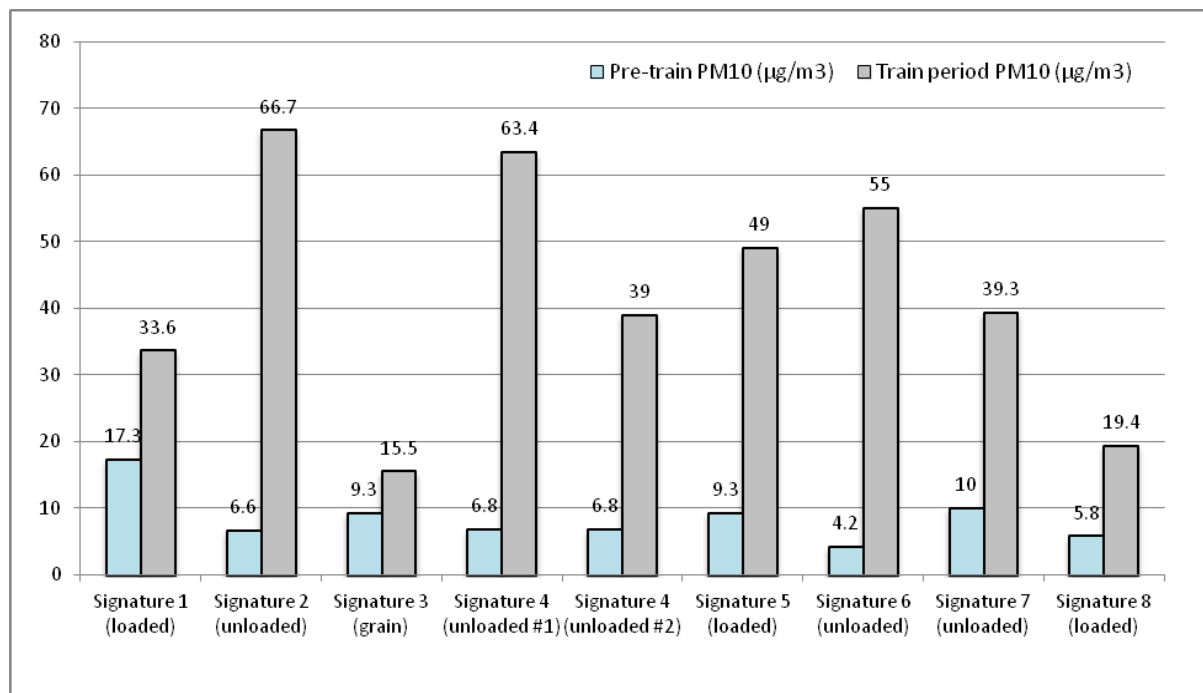
Chart 2: Particulate concentrations (PM₁₀) associated with train signatures

The following chart and table provides a summary of PM₁₀ particulate concentrations of the eight pollution signatures.

Note: The PM₁₀ levels depicted above are two minutes averages of pre-train and train pass-by and are not peak levels recorded.

All coal train signatures were associated with a significant increase in PM₁₀ particle pollution levels. In the case of Signatures 1 and 5, this represents increases of 94% and 427% respectively for loaded coal trains. Signature 6 increased PM₁₀ concentrations significantly, up to 1210%. In sum, coal trains increase PM₁₀ levels by between 94% and 1210%. While coal trains pass, particle pollution concentrations increase up to 13 times pre-coal train levels.
